# Manhole Inspection Summary

Manhole # S19M\_\_019MH

Insp Date: **3/25/08 11:16 AM**

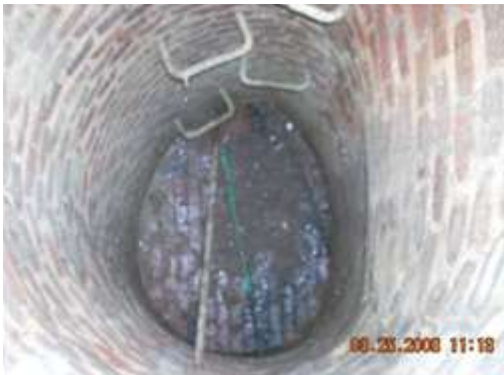
Defect 1

**Steps** Count: **6** Missing: **0** ☒ **Corroded**

Corroded Steps

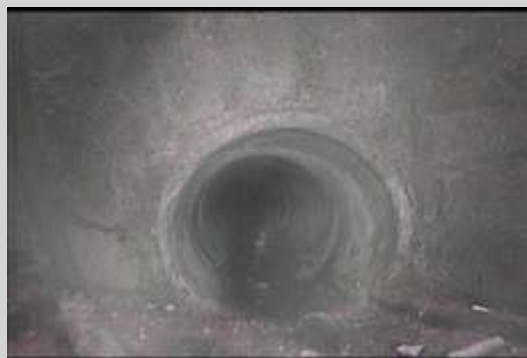
12 O'Clock Outflow

8 in. Circular Gravity Sewer  
Pipe Out @ 12 O'Clock

Pipe Height: **8.4** (in.) Rod and Bar (Angled)

Pipe Material: **Clay** ☐ Pipe Lined

Invert Depth: **9.90** (ft.) Flow Characteristics: **None**

Deposits: ☒ None ☐ Mud ☐ Sludge ☐ Debris ☐ Grease

Infiltration: **None** Pipe Seal Cond: **Sound**
